STRUCTURAL INTEGRITY OF STEEL HYDROCARBON PIPELINES WITH LOCAL WALL DISTORTIONS

ABSTRACT

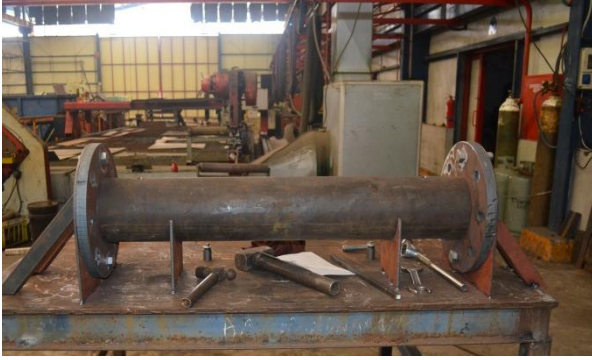
Figure 2: 6-inch X52 pipe specimens.

The six specimens are 1-meter-long X52 seamless 6-inch pipes with nominal thickness 4.78 mm ($\varnothing 168.3/4.78$), corresponding to $D/t = 35$. The specimen ends are capped with thick plates, to enable the application of internal pressure and the connection with adjacent pipe parts for the experimental set-up.

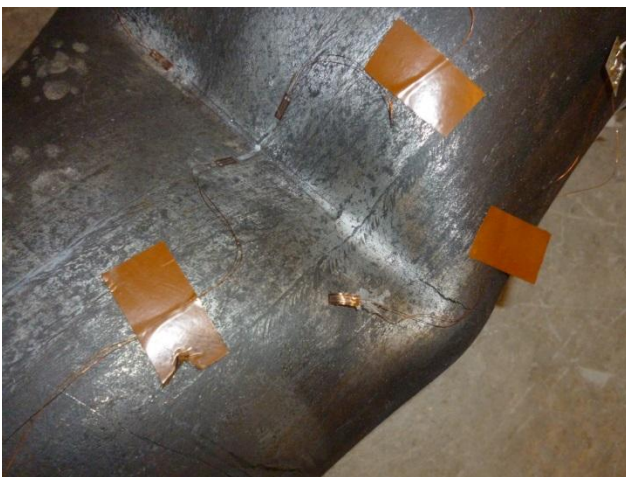
Figure 5: Instrumentation of pipe specimen.

Prior to denting, uniaxial strain gauges were installed on several critical points along the outside surface of the specimen, close to the region where the dent would be developed, in order to identify local strains during the denting procedure (Figure 5).

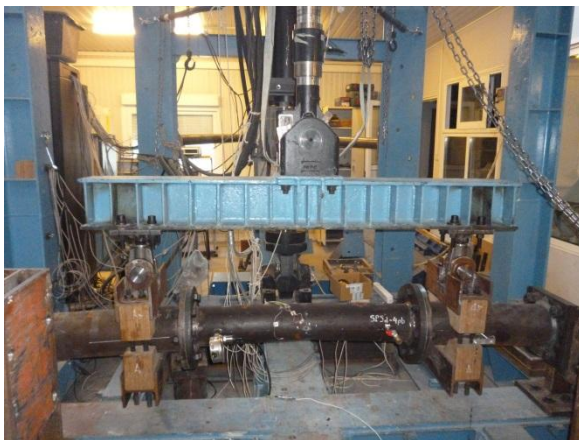
Figure 7: Four-point bending experimental set-up.

The set-up employed for conducting cyclic bending on the dented specimens is shown in Figure 6 and Figure 7. The 1-meter long specimen is connected on either side to two heavy-walled 7-inch-diameter 650-mm-long tube segments ($\varnothing 193.7/10$) made of high-strength steel using a bolted connection (Figure 7). The entire system is 2.615-meters long, it is hinged at the two ends (Figure 8a) and it is connected to the 600-kN-force-capacity hydraulic actuator through a cross-beam and two wooden clamps (Figure 8b). This corresponds to a four-point bending structural system, where cyclic bending is applied through the vertical motion of the hydraulic actuator. The hinges of this 4-point bending set-up also minimizes the axial load introduced during the monotonic tests, because of the constraints applied by the wooden grips and the supports. Using appropriately located strain gauges the maximum value of this at maximum bending load axial force was calculated to be less than 8% of the cross-sectional axial yield strength and it is considered negligible.

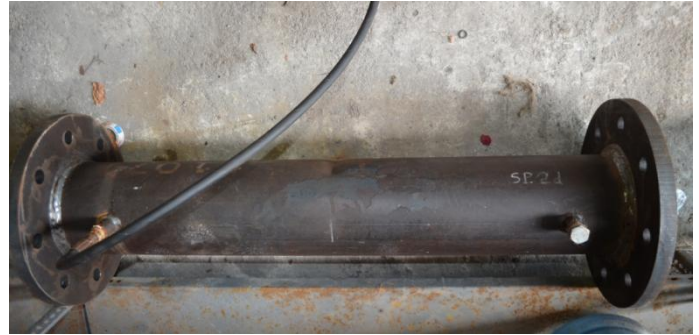
Figure 9: Pressure application on specimens.

The two specimens have been pressurized with the use of a 400-bar-capacity water pump (Figure 9). Cyclic pressure has been applied with maximum and minimum values equal to 150 bar and 15 bar respectively, at a frequency of about 0.1 Hz. Following cyclic testing, the specimen was pressurized monotonically until burst.

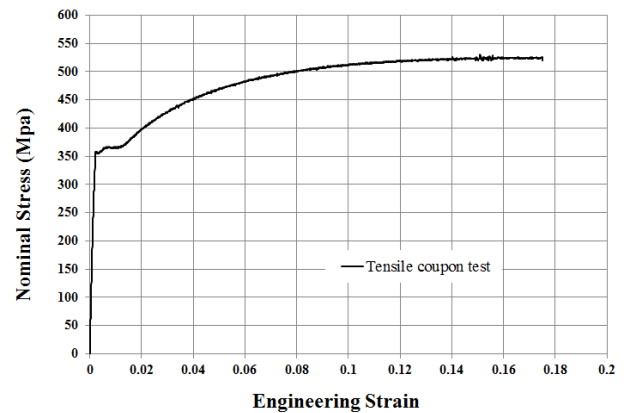
Figure 10: Material curve of X52 steel grade

Monotonic and low-cycle fatigue tests were performed on the X52 steel pipe material to determine material properties. Strip specimens have been extracted from the seamless 6-inch pipes, in the longitudinal direction and machined in accordance with the ASTM E606 standard. The material stress-strain curve was obtained from tensile coupon tests and is shown in Figure 10, indicating a yield stress (σ_Y) equal to 356 MPa, very close to the nominal value, and an ultimate stress (σ_{UTS}) equal to 554.7 MPa at about 18% uniform elongation.

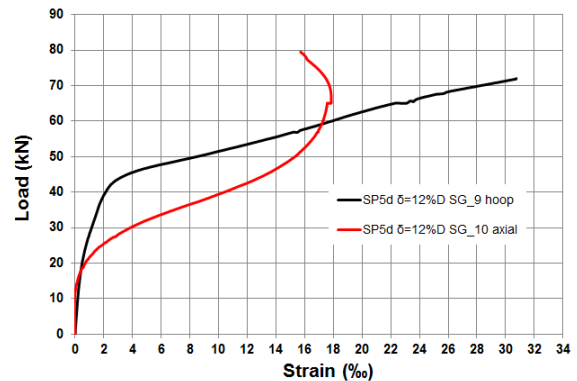
Figure 13: Longitudinal and hoop strain distribution during denting for specimen SP5d ($d/D = 12\%$).

The denting load is applied vertically through the hydraulic actuator at a very low speed until a maximum value of dent depth of about 16 (for SP1d, SP4d and SP6d) and 27 mm (for SP2d, SP3d and SP5d), and subsequently, the load was removed. The remaining dent depth after the elastic “spring back” is measured about 11mm and 21mm corresponding to $d/D = 6\%$ and $d/D = 12\%$ respectively. In Figure 12 the denting load-stroke curves for specimens SP5d and SP6d are presented. The increase of axial and hoop local strains is illustrated in Figure 13. The dent results are summarized in Table 1.

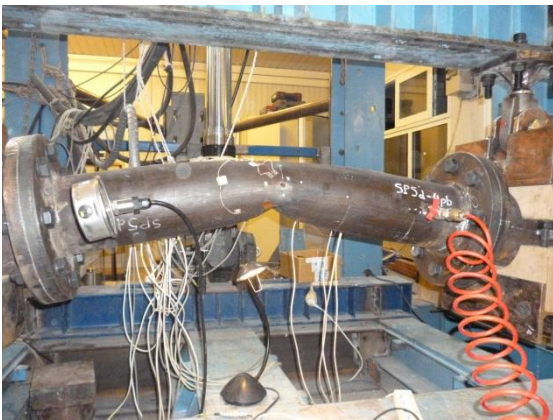
Figure 15: Dented specimen SP5d during cyclic 4-point bending.

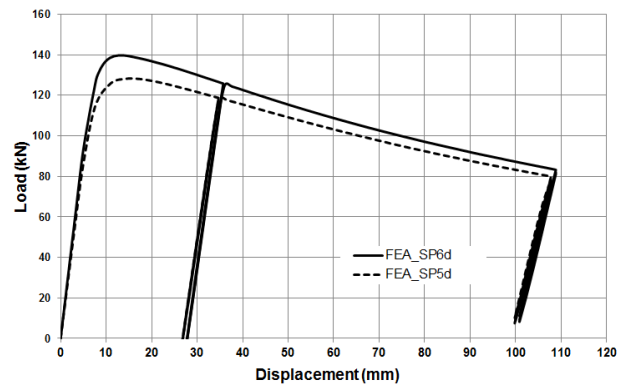
Figure 22: Load-displacement curve during bending of specimens SP5d and SP6d (monotonic and cyclic bending) obtained from finite element analysis.

Following denting, cyclic bending loading of the dented pipe is simulated, similar to the experimental procedure. Figure 21 and Figure 22 show the load-displacement curves for those analyses, and compared fairly well with the experimental curves shown in Figure 14 and Figure 15. During the numerical simulation, cyclic bending loading of the specimens is performed at the loading stages corresponding to the experimental procedure. At each of these stages, a total of 10 cycles is performed numerically, and the corresponding range of maximum local strains in the longitudinal direction with respect to the pipe axis is measured and depicted in Table 4.
