UNIVERSITY OF THESSALY

DEPARTMENT OF MECHANICAL ENGINEERING

Ph.D. Dissertation

**STRUCTURAL INTEGRITY OF STEEL HYDROCARBON  
PIPELINES WITH LOCAL WALL DISTORTIONS**

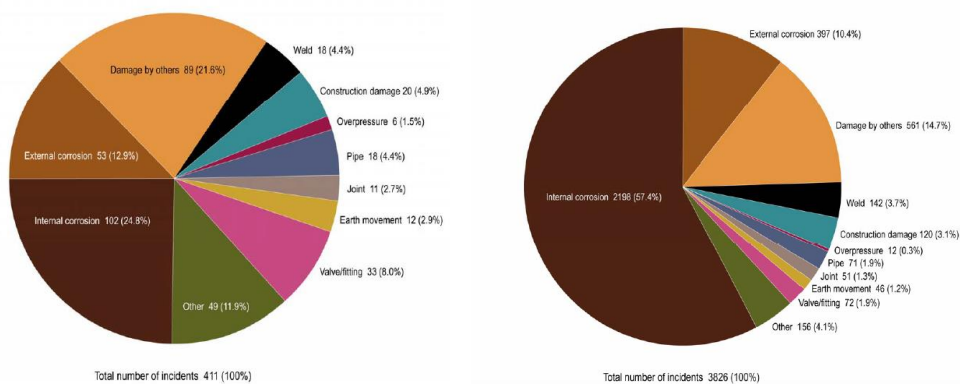
Figure 2-1: Pipeline Incidents by cause (1990-2005); (a) Crude Oil and (b) Natural Gas pipelines [6].

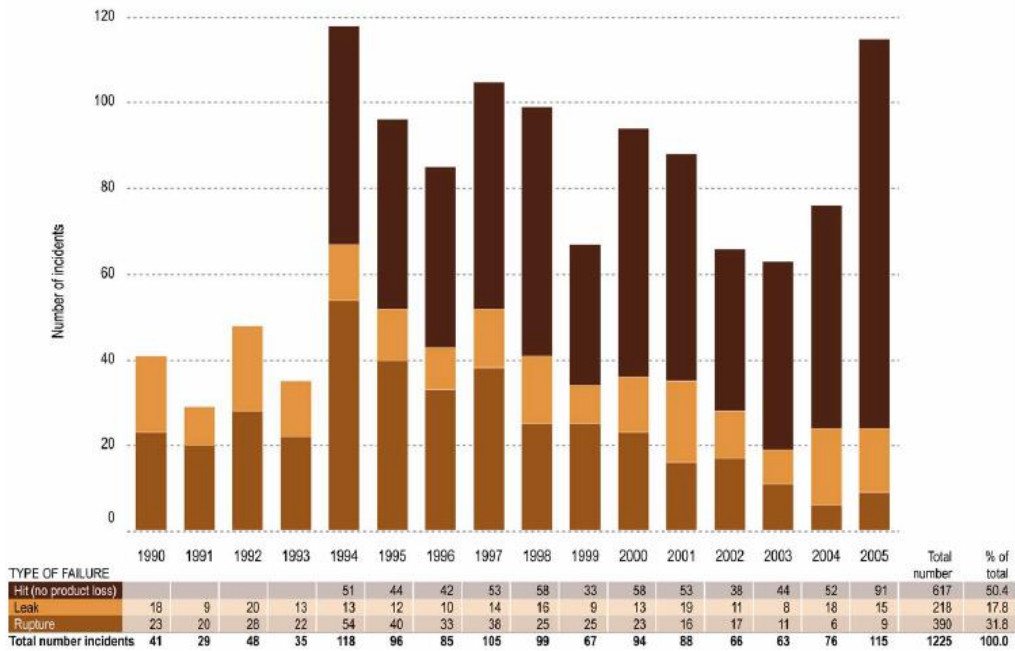
Figure 2-2: Pipeline incidents due to third-party damage per year (1990-2005)[6].

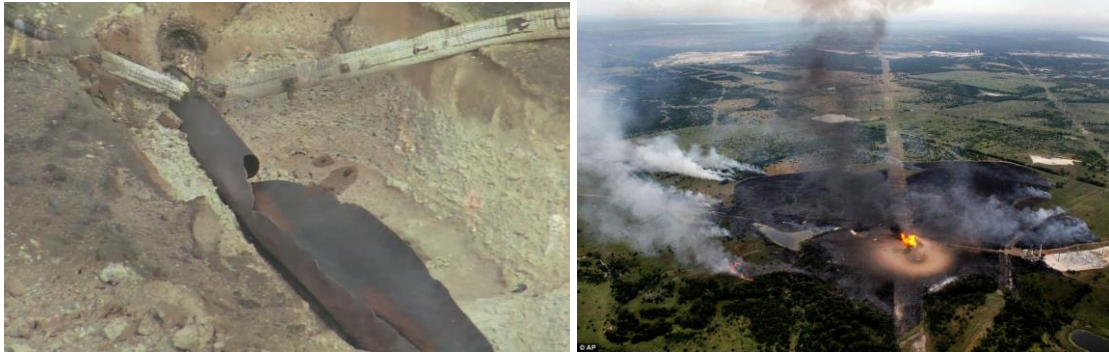
Figure 2-3: Gas pipeline explosion in North Texas; (a) ruptured pipeline (b) the burned pipeline surroundings. [<https://www.youtube.com/watch?v=RSCz-35M9hA>]

A representative example of pipeline failure due to external “hit” occurred more recently, in North Texas: In 2010 a large natural gas line in North Texas, near Granbury, erupted after utility workers accidentally hit an Enterprise Products Partners natural gas pipeline. The pipeline exploded killing one worker. The ruptured pipeline and the damaged area after the explosion are shown in Figure 2-3. [Source: <http://www.dailymail.co.uk/news/article-1284880/Texas-gas-pipeline-explosion-kills-worker-injures-seven.html#ixzz3dpBySx9h>]

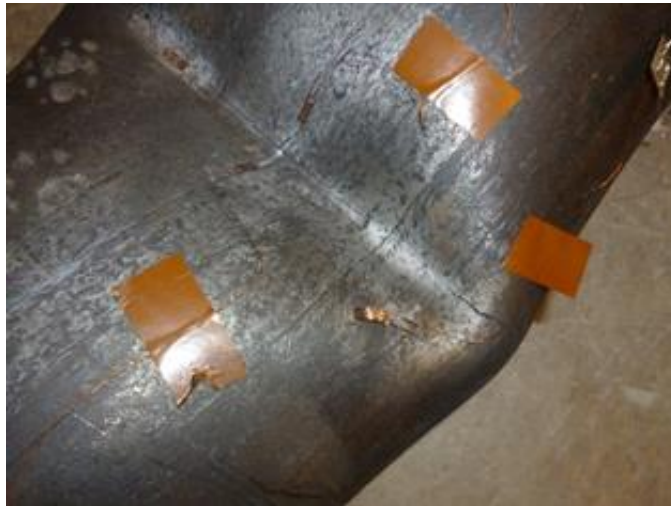
*Figure 3-38: Pipe wall rupture of specimen SP5d due to cyclic bending loading at the dent "ridge".*

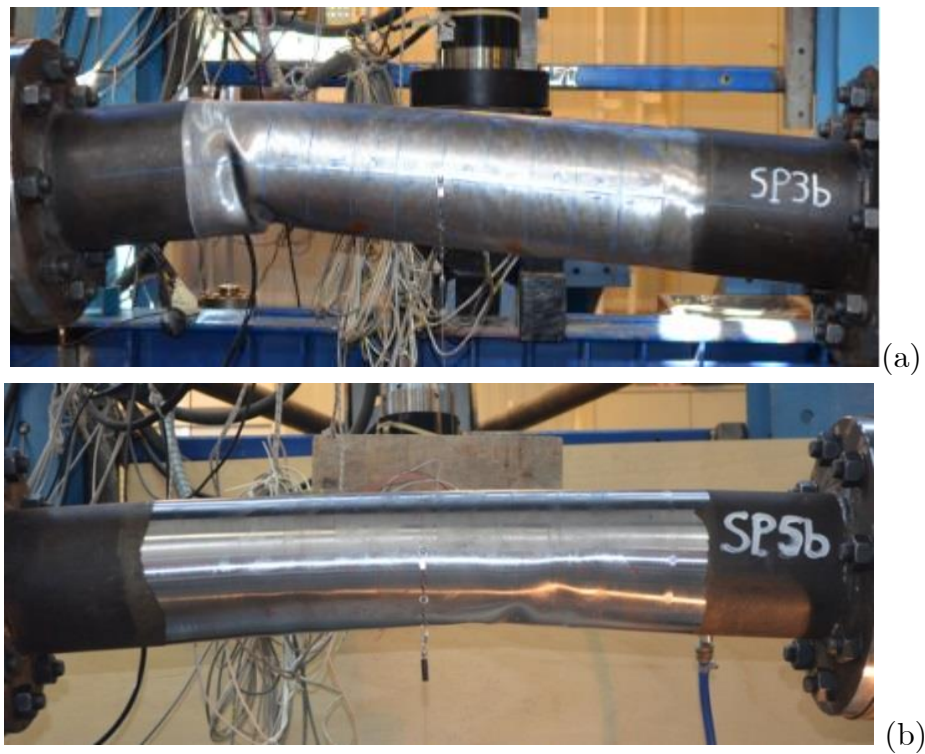
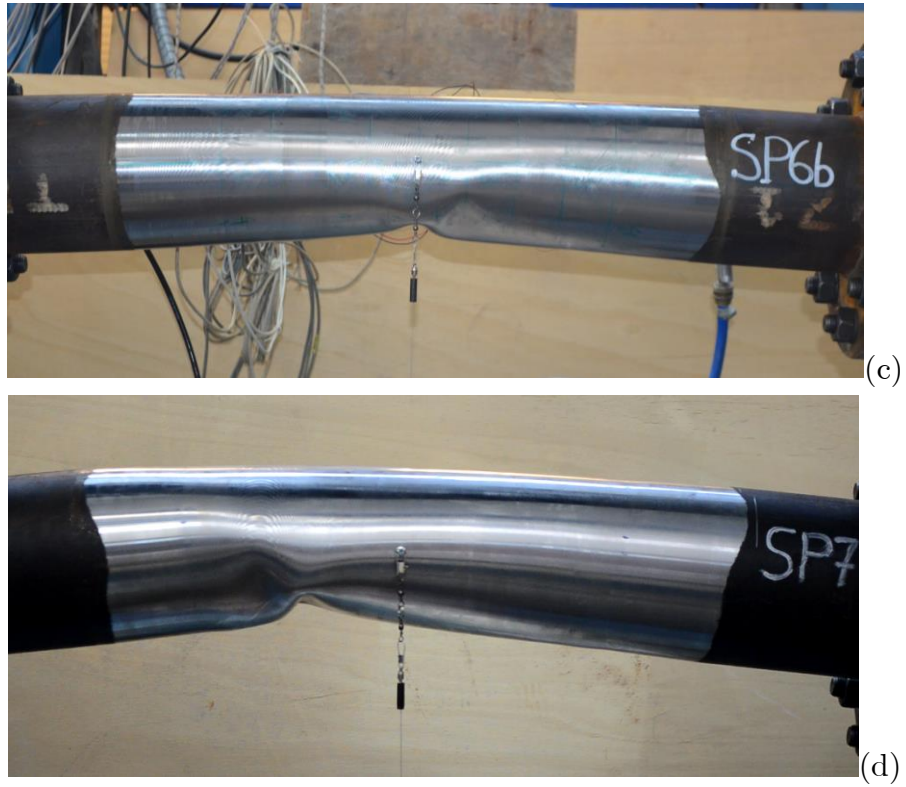
*Figure 3-51: Side views of buckled specimens (a) SP3b, (b) SP5b, (c) SP6b and (d) SP7b buckled specimens.*

The final buckled shapes of the specimens before the application of cyclic bending are shown in Figure 3-51. In particular, Figure 3-51c, shows that specimen SP6b buckled almost exactly at the midspan. For the most cases of pipe specimens the buckling pattern consisted of a diamond-type shape with one major and two minor buckles on each side of the bending plane, as shown clearly in Figure 3-52b. On the other hand, the buckled mode of specimens SP5b and SP8b, consisted of two main buckles perpendicular to the pipe main axis on each side of the bending plane (Figure 3-52c).

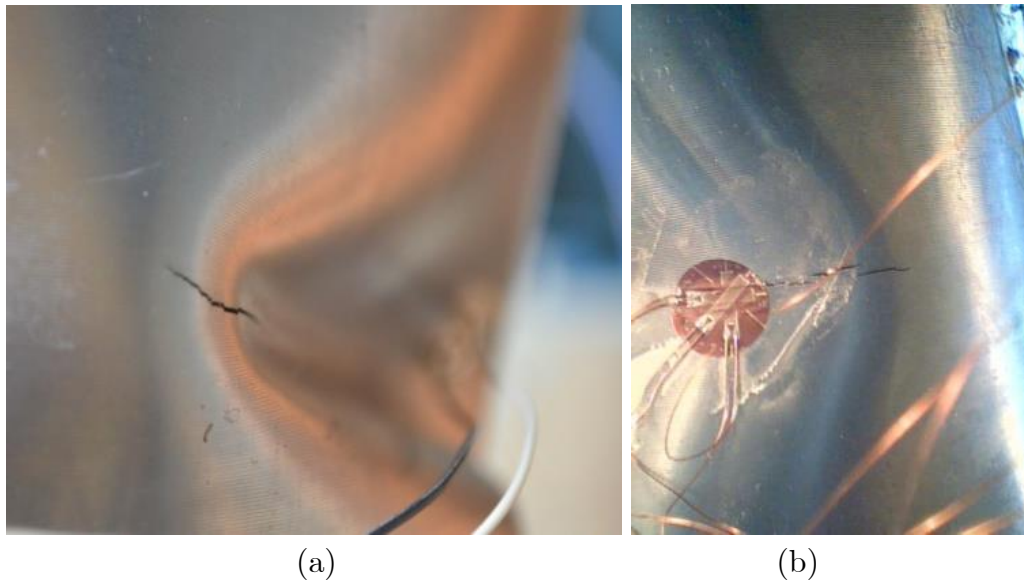
*Figure 3-56: Location of final cracking; (a) SP4b and (b) SP5b and (c) SP6b specimens*

The locations of the final cracks on the buckled specimens SP4b-SP6b are presented in Figure 3-56. It is observed that for SP5b and SP6b, the crack was initiated at the location where the tri-axial strain gauge was initially placed before the cyclic loading stage, and propagated along the hoop direction.

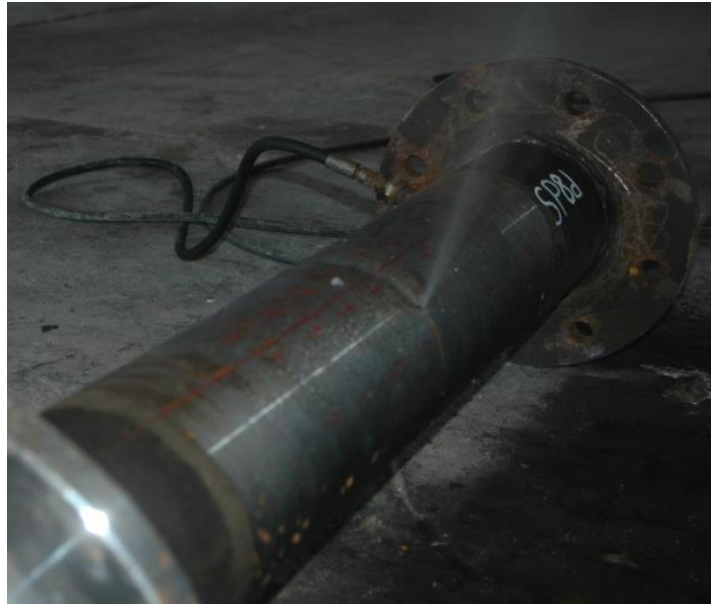
*Figure 3-57: Rupture  $\text{Ø}165/3$  pipe specimen SP8d due to cyclic internal pressure; wall rupture location at the "ridge" of the dent location.*

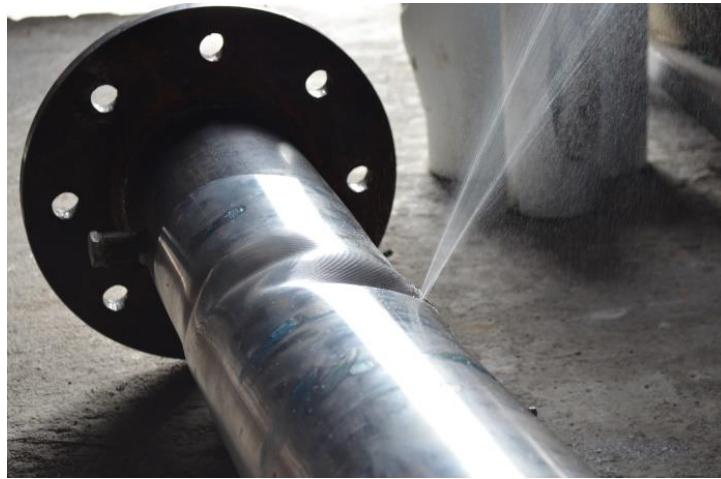
*Figure 3-59: Ruptured  $\varnothing 165/3$  pipe specimen (SP7b) due to cyclic internal pressure; wall rupture location at the buckle location*

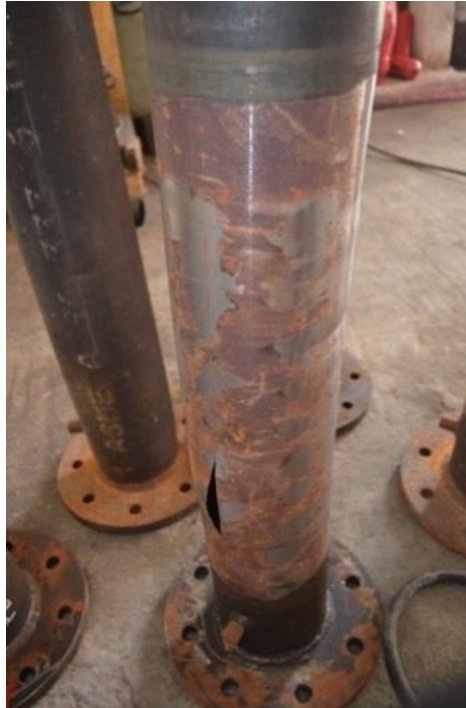
*Figure 3-60: Rupture of SP8b specimen, away from the buckled area*

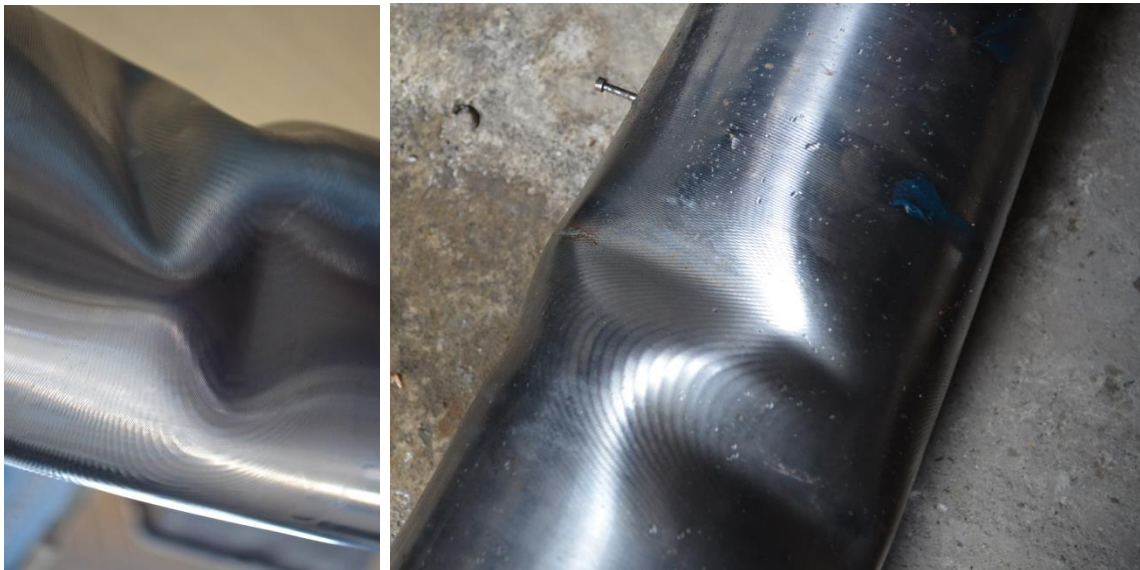
*Figure 3-61: Buckled specimen SP7b: (a) buckle region prior to pressure application and (b) after cyclic internal pressure*

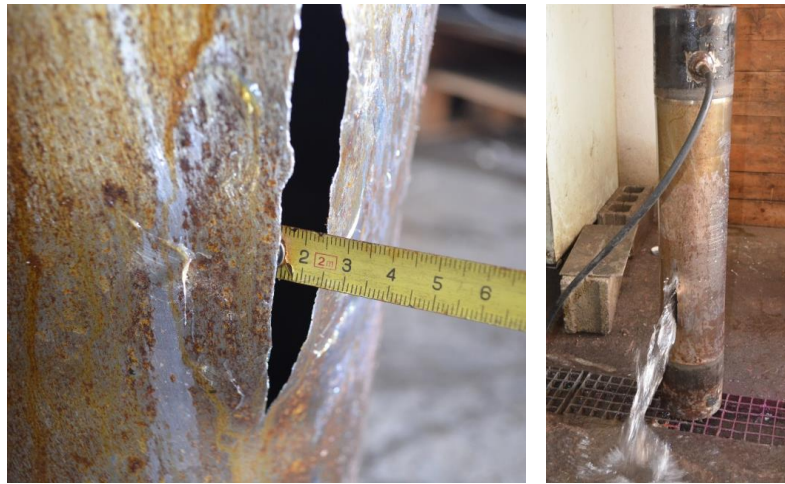
*Figure 3-62: Rupture of perfect  $\text{Ø}165/3$  pipe specimens; (a) thickness wall reduction at the critical region and (b) the location of the rupture.*

specimen were capped with steel caps. The perfect  $\text{Ø}165/3$  tube failed at a level of 50 bar (5MPa) which is about the 1/4 of the theoretical value of burst pressure. As shown in Figure 3-62, the rupture occurred at the one side of the pipe machined central part, close to the transition thickness zone. This “early” failure can be attributed to the fact that, with the application of internal pressure, the thickness value at the rupture region was decreased to 1mm. On the other hand the  $\text{Ø} 168.3/4.78$  specimen failed at a burst pressure 35MPa, which is somewhat larger than the theoretical burst value. The rupture was located at the center of the specimen.

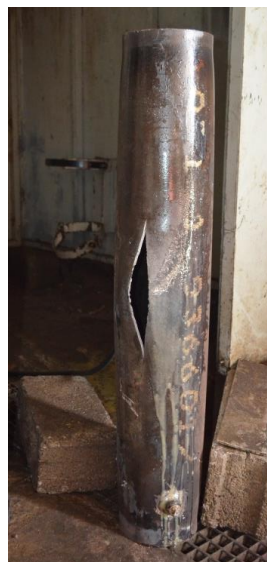
*Figure 3-63: Rupture of perfect  $\text{Ø} 168.3/4.78$  specimen*

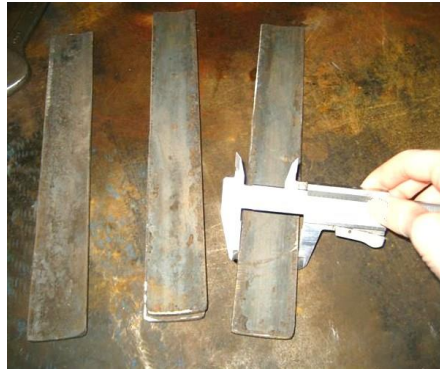
*Figure 3-64: Geometry of Strip specimens*

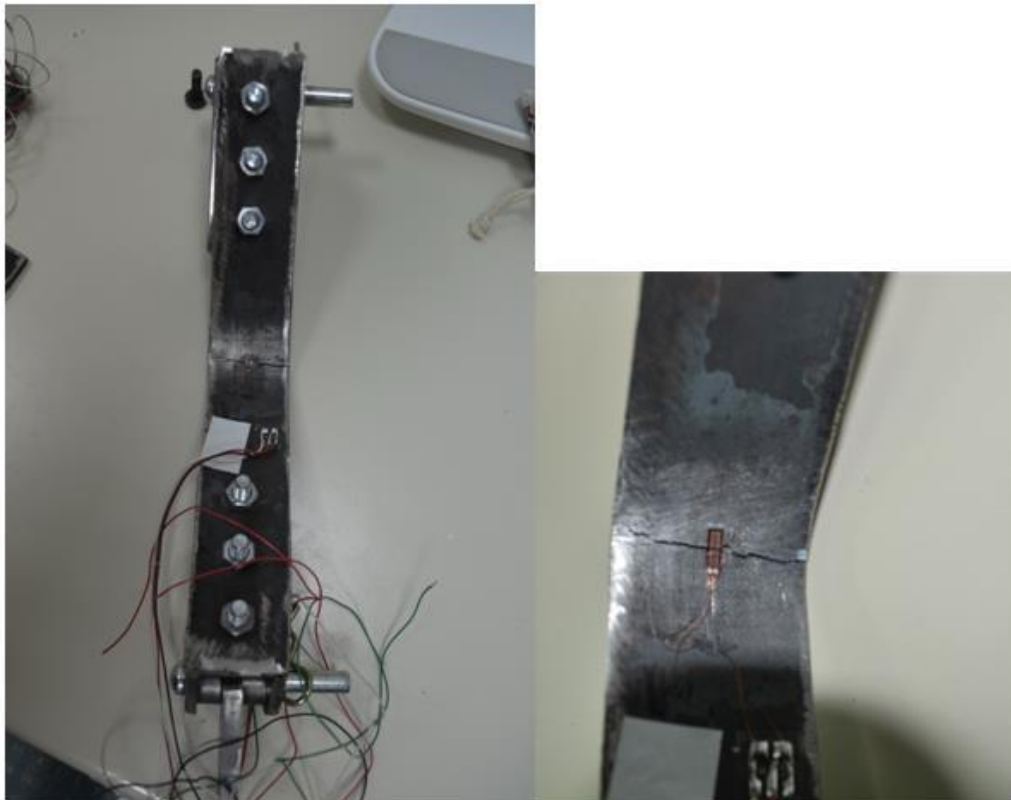
Figure 3-81: Crack development of specimen S21-View from the inner face of the strip. The crack propagated along the transverse direction.

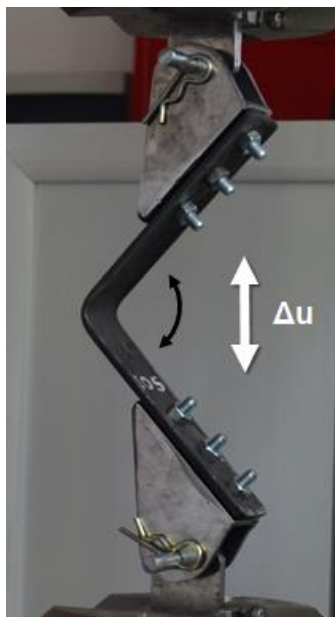
Figure 5-3: Loading and test configuration of strip specimens
